Case Study

Anaerobic Digester Cleaning

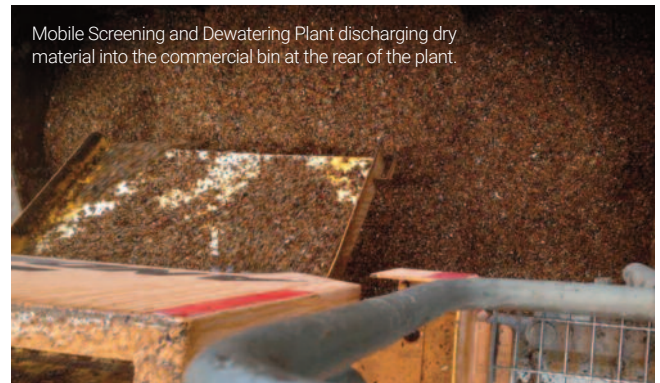
Mobile Screening and Dewatering Plant discharging dry material into the commercial bin at the rear of the plant.

The wet material was then blown from the Disab into our mobile screening and dewatering plant which processed the material and deposited the dry material into a commercial bin at the rear of our mobile screening and dewatering plant. The customer removed the commercial bin using a forklift and tipped the dry material into their dry waste bays onsite for disposal.

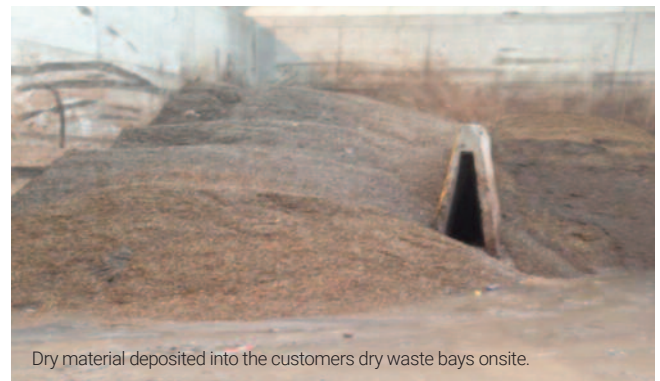
Dry material deposited into the customers dry waste bays onsite.

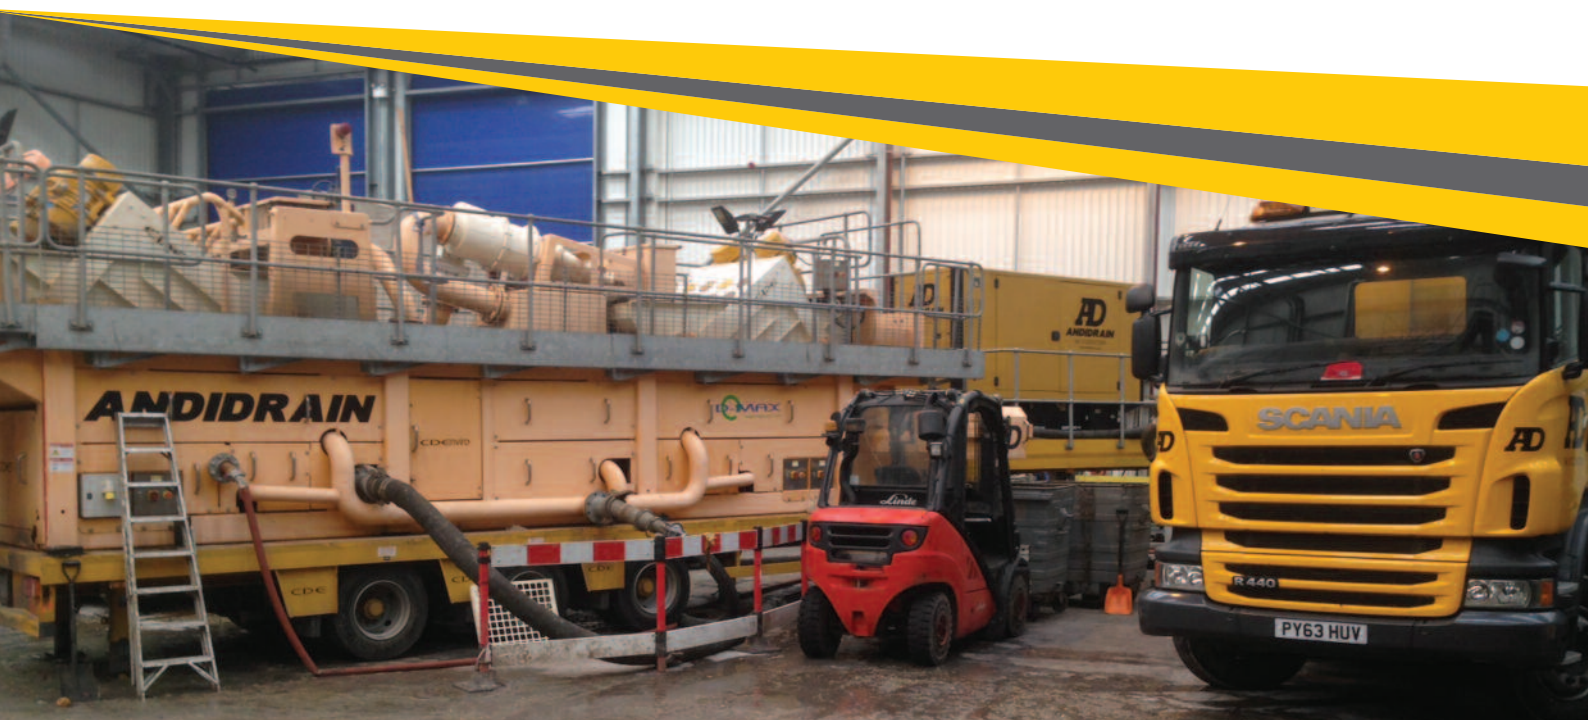
DISAB and Mobile Screening and Dewatering Plant.
