Case Study

Pipe Cleaning and Surveying

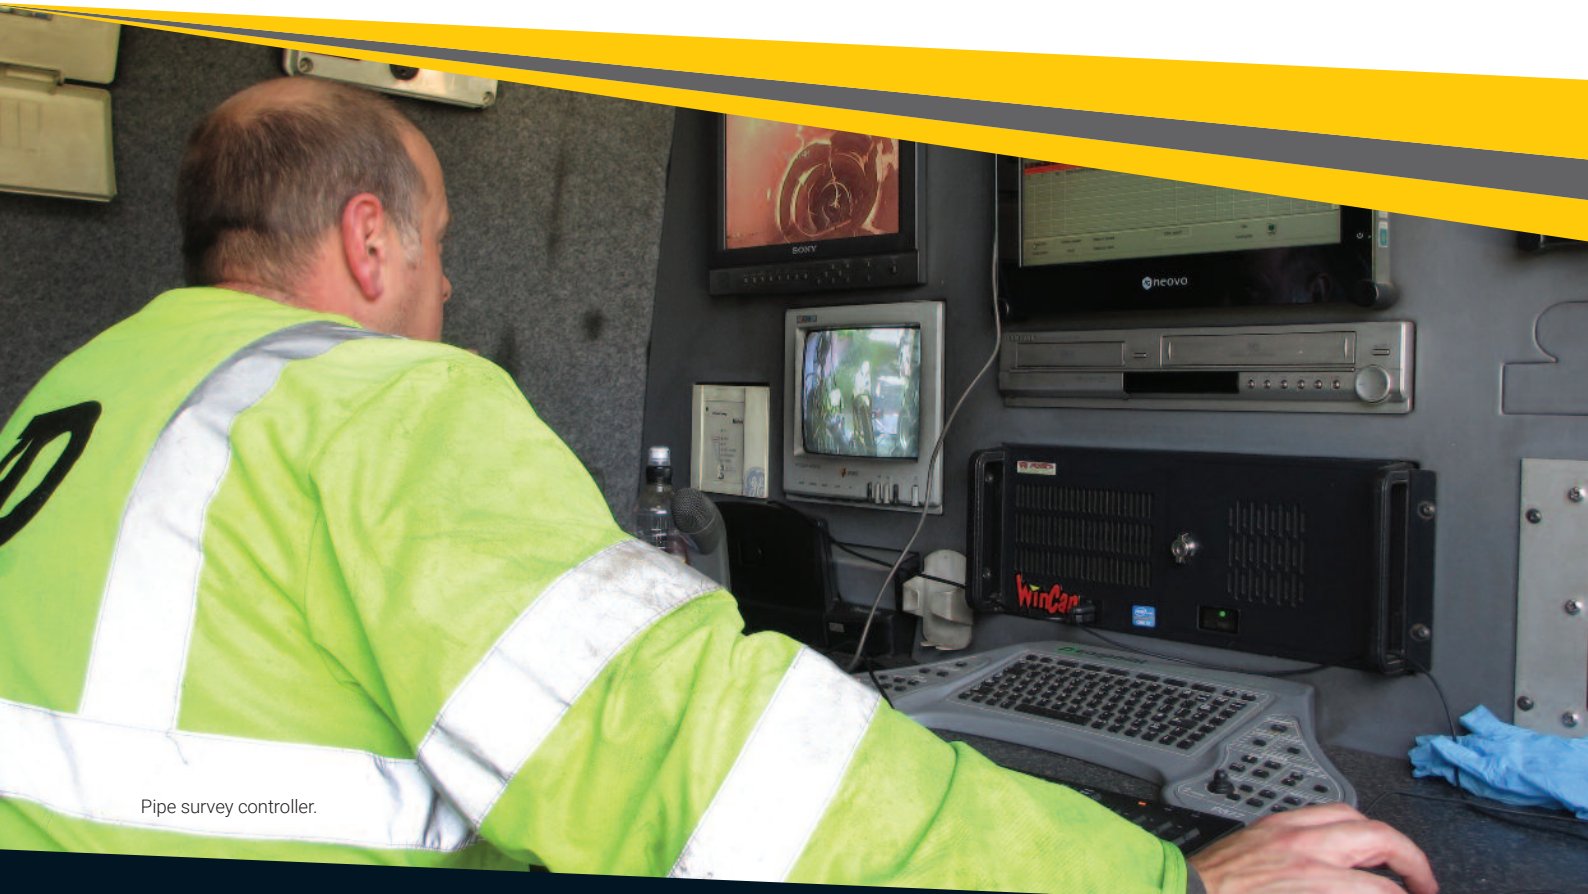
Pipe survey controller.
